CTCLUSI Environmental Assessment of Tribal Lands

September 2011

1.0 INTRODUCTION

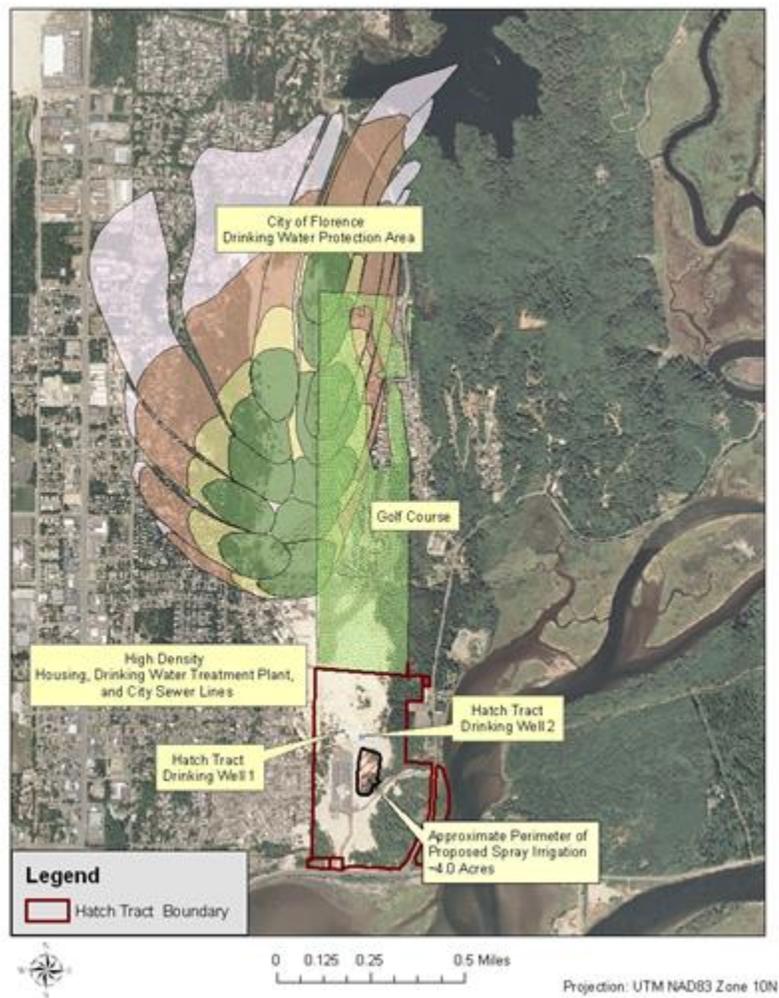
**Potential Contaminant Sources
that Pose a Risk to Hatch Tract Groundwater**

According to the Florence Source Water Assessment Report, the North Florence Dunal Aquifer is considered to be highly sensitive and susceptible to contamination from viral contaminant sources located within the two-year time-of-travel zone for the city's drinking water protection area (e.g. sewer lines and residential housing). The City of Florence's Drinking Water Protection Area is approximately one mile upgradient of the Tribes' Hatch Tract facilities, but does not include Hatch Tract in its delineation. However, due to the close proximity of Hatch Tract to the City of Florence's Drinking Water Protection Area, the potential contaminant sources for Hatch Tract source water are similar to those identified by the City of Florence Source Water Assessment Report. The delineated drinking water protection area for the wells located within the Florence drinking water protection area is primarily dominated by residential and municipal land use. However, four potential contaminant sources were identified in the two-year time-of-travel zone of the Florence drinking water protection area: a golf course; high density housing; a drinking water treatment plant; and city sewer lines. These findings were confirmed by our own GIS analysis and pose the same threat to Tribal source water resources at the Hatch Tract.

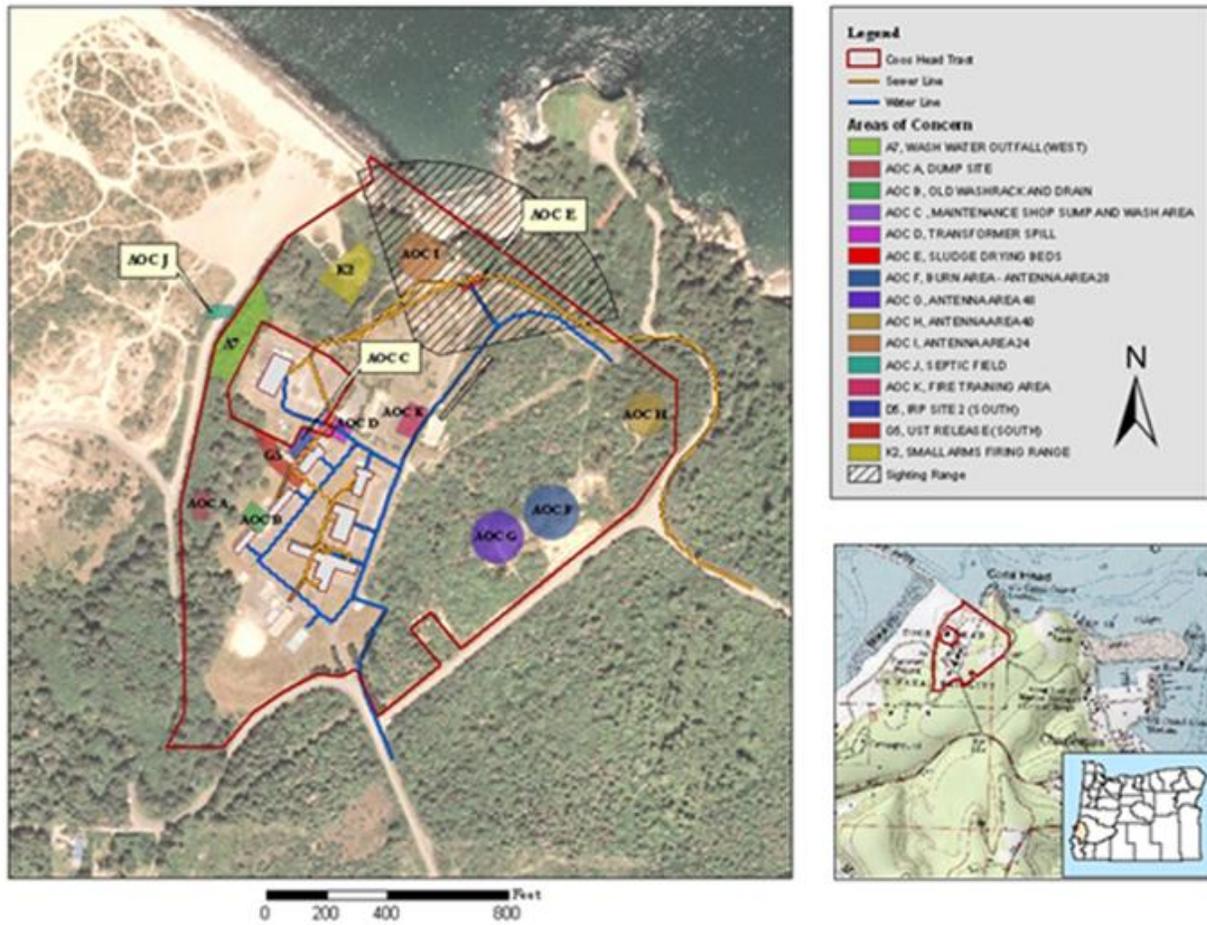
Map.1

During the military's tenure, several hazardous materials were discharged at the site. Investigations of these discharges have resulted in the identification of several areas of concern (*Map 1*). The Oregon Air National Guard (ANG) has accepted and retains responsibility for site remediation in accordance with various federal laws and their implementing programs (the Oregon ANG contact person is Roger C. Rein, Civ ORANG 142 FW/Environmental Manager, 506-665-4462). Under the terms of the Department of Defense and State Memorandum of Agreement (DSMOA) for Oregon, the Oregon Department of Environmental Quality (ODEQ) is providing oversight to the Oregon ANG.
