CONFEDERATED TRIBES OF THE COOS, LOWER UMPQUA, AND SIUSLAW INDIANS

Wetlands Inventory and Assessment

November 2016

CONFEDERATED TRIBES OF THE
COOS, LOWER UMPQUA, AND SIUSLAW INDIANS
WETLANDS INVENTORY AND ASSESSMENT REPORT

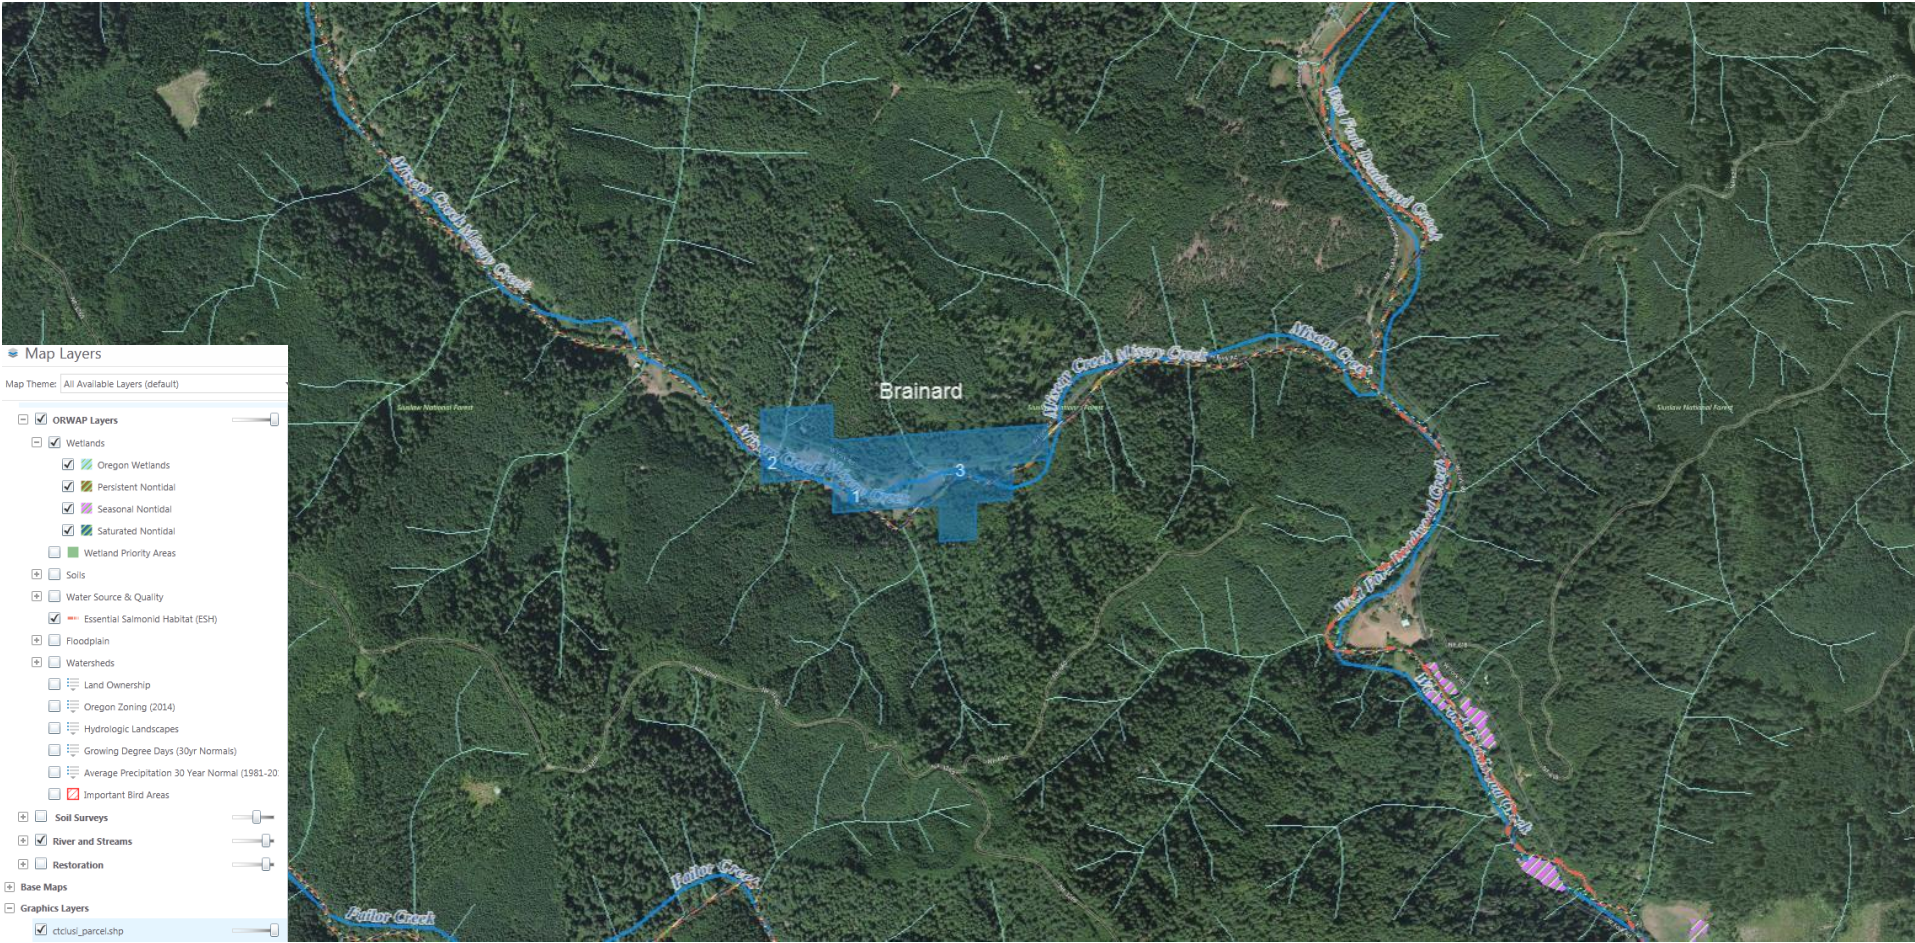
Deadwood, Siuslaw Watershed; Lower Deadwood Creek Sub-basin

The Brainard Tract is a 35.59 acre parcel located in Lane county about 5 miles northwest of Deadwood, OR. The site comprises a mostly mixed stand of red alder and big leaf maple trees with Misery Creek, a tributary of the West Fork Deadwood creek, flowing through the southern portion of the property. The surrounding woodlands also contain a mixed stand of second growth Douglas fir, cedar, and a few western hemlock trees.

According to the National Wetlands Inventory (NWI), this property is comprised of approximately 6.29 acres of freshwater emergent wetland (PEM1C), 2.99 acres of freshwater forested/shrub wetland (PFO1C), 1.51 acres of riverine wetland type R3UBH, and 6.9 acres of riverine type R3USC.

During an on-site investigation of this tract, Misery creek appeared to be incised in some stream reaches and entrenched in others. Bank instability and erosion may be attributing to the sediment deposition observed in Misery Creek. Because this property lies in a valley, future logging endeavors conducted by the Siuslaw National Forest, which encompasses this property could be expediting soil erosion and attributing to the sedimentation observed in the creek. Agricultural practices occurring upstream may also be contributing a minute amount of sediment to the creek.

Restoration project development for this property should include removing non-native invasive species, especially Armenian blackberry, and planting native species that help stabilize the stream bank and capture/filter sediments to prevent further incisement/entrenchment. Future surveys should include intrinsic potential surveys for specific fish species, such as salmonids and lamprey, that were historically present in Misery Creek as well as fish surveys and fish passage barriers before restoration projects, which may include large woody debris placement, are developed and implemented.

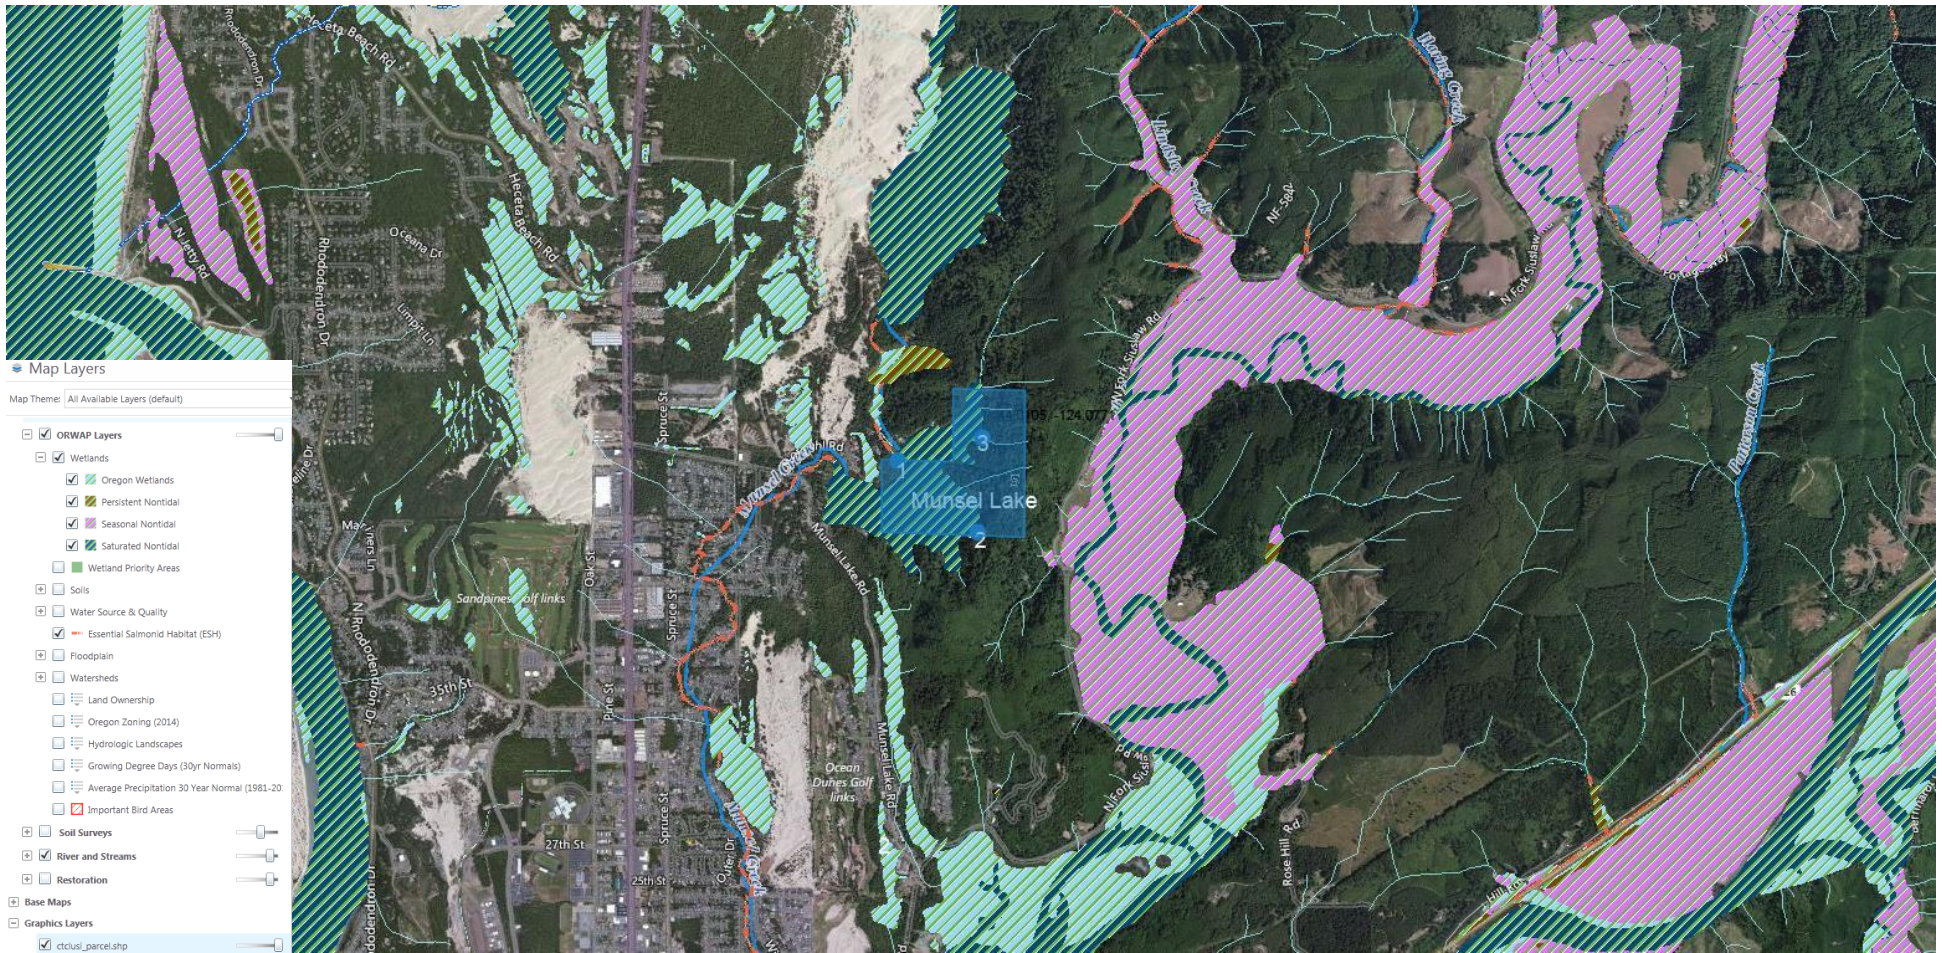
Munsel Lake, Siuslaw Watershed; Bernhardt Creek-Siuslaw River Sub-basin

The Munsel Lake Tract is a 120 acre parcel located in Lane County along the eastern shore of Munsel Lake approximately three miles north and 1 mile east of the city of Florence, Oregon. While 48% of this tract is submerged, 40% of the terrestrial portion of the CTCLUSI's Munsel Lake Tract is characterized by hillsides that range in percent slope of between 50 to 75%. The headwaters for the Munsel Lake originate in Collard Lake, flow south through Clear and Ackerly Lakes, and into Munsel Lake via Clear Creek.

Approximately 2.19 acres of riverine wetland type (R4SBC), 0.034 acres of riverine wetland type R4UBH, and 105.87 acres of lake wetland type L1UBH are inventoried on this property according to the NWI.

There are no real known environmental issues affecting wetland areas on this tract at this time. However, an increase in sediment and nutrient loading in the near future from increased recreation, shoreline properties, roads and /or failing septic systems compounded by climate change could lead to water quality degradation, eutrophication, and cyanobacteria blooms. An on-site investigation of this property revealed a few invasive species, including but not limited to *Charra spp*, *Najas spp*, *Isoetes spp*, *Potamogeton amplifolius*, and *Nymphaea odorato*. A more thorough on site investigation will need to be performed to inventory non-native invasive species as well as culturally significant wetland species, and rare, threatened and endangered species.

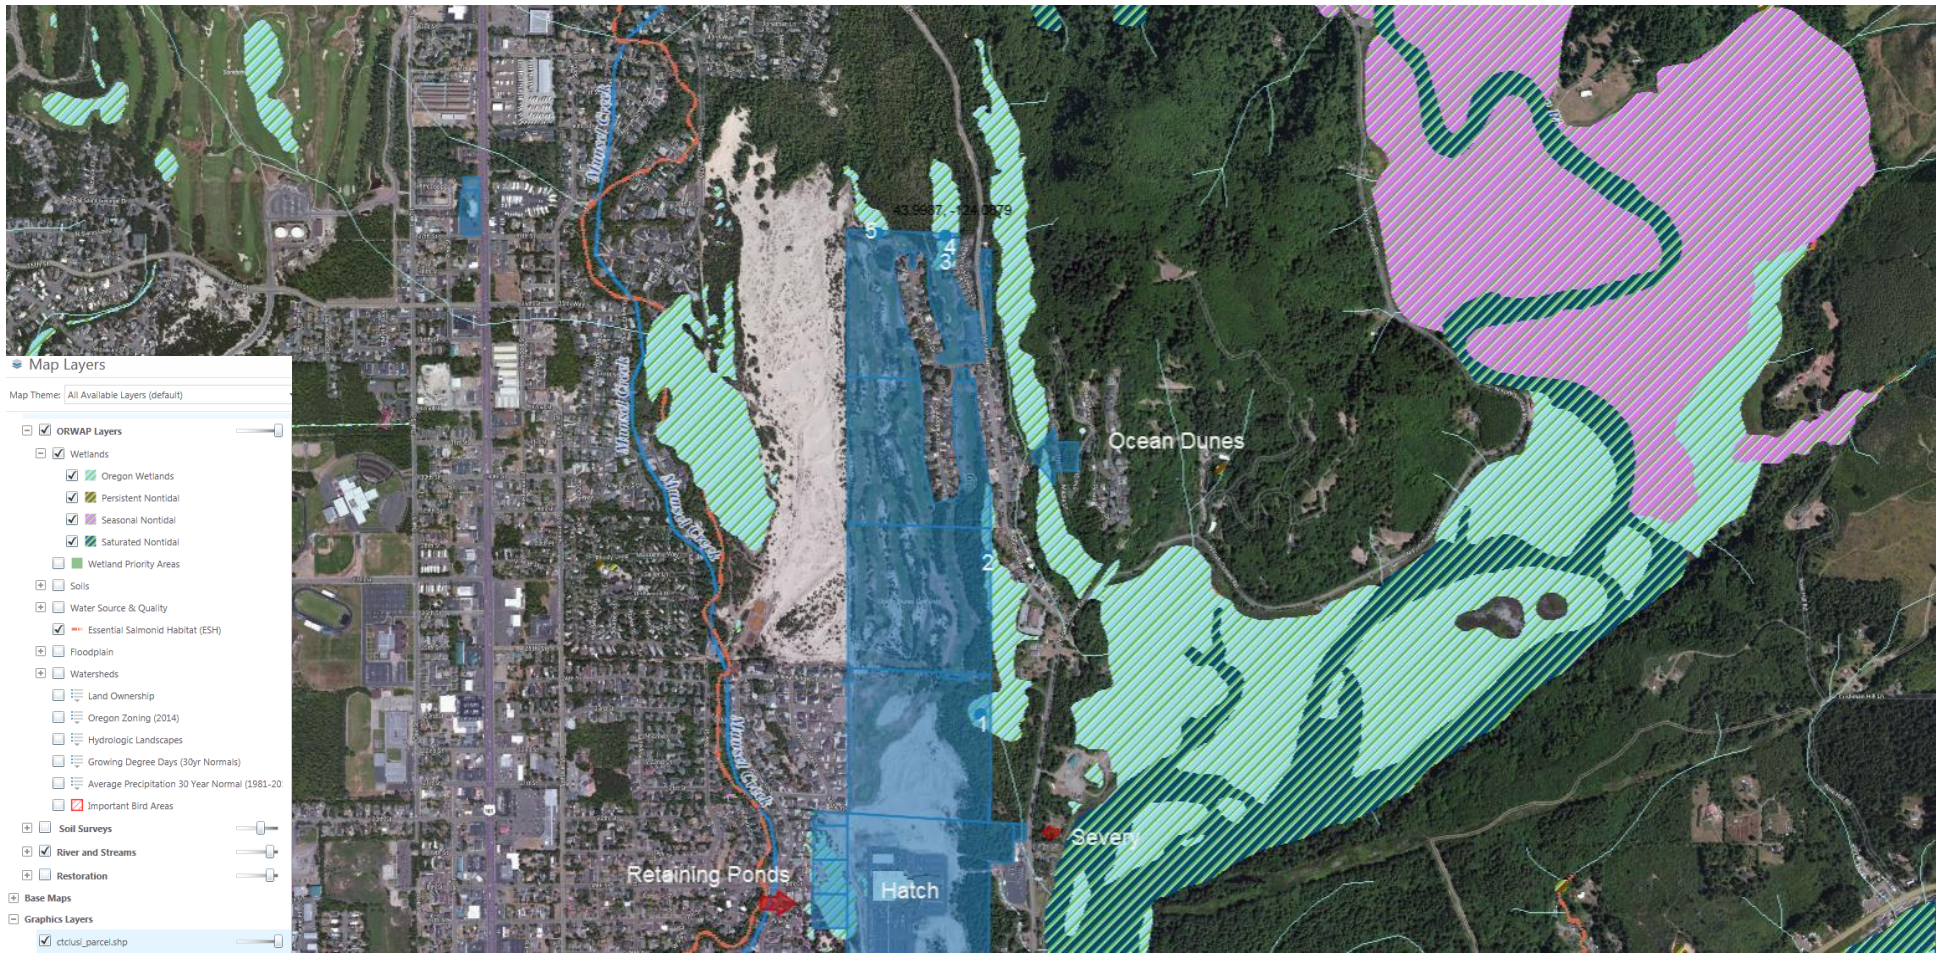
Ocean Dunes, Siuslaw Watershed; Lower North Fork Siuslaw River Sub-basin

The Ocean Dunes tract is a 135.70 acre parcel located in the city of Florence, Oregon and is home to the Ocean Dunes Golf Course. Hatch tract, another tract owned by the Tribes, is located due south as well as the Peterman tract, which lies directly adjacent to the Ocean Dunes Tract.

According to the National Wetlands Inventory (NWI), this property is comprised of approximately 1.31 acres of freshwater forested/shrub wetland type PFOC, 0.91 acres of freshwater forested/shrub wetland type PSSC, 1.91 acres of freshwater forested/shrub wetland, type PFOA, and 4 freshwater ponds (PUBH_x) totally 2.04 acres.

During the last on-site investigation for this tract, non-native invasive species, especially gorse, scotch broom, Armenian blackberry, and European beach grass were found heavily interspersed throughout the track. An abundance of culturally significant wetland species was also present on this

Restoration project development for this property should include removing non-native invasive species and enhancing native wetland plant species that help to filter contaminants. Encouraging the Ocean Dunes Golf Course to utilize eco-friendly weed killers and fertilizers will also help to alleviate nutrient loading and contamination concerns in this wetland drainage.

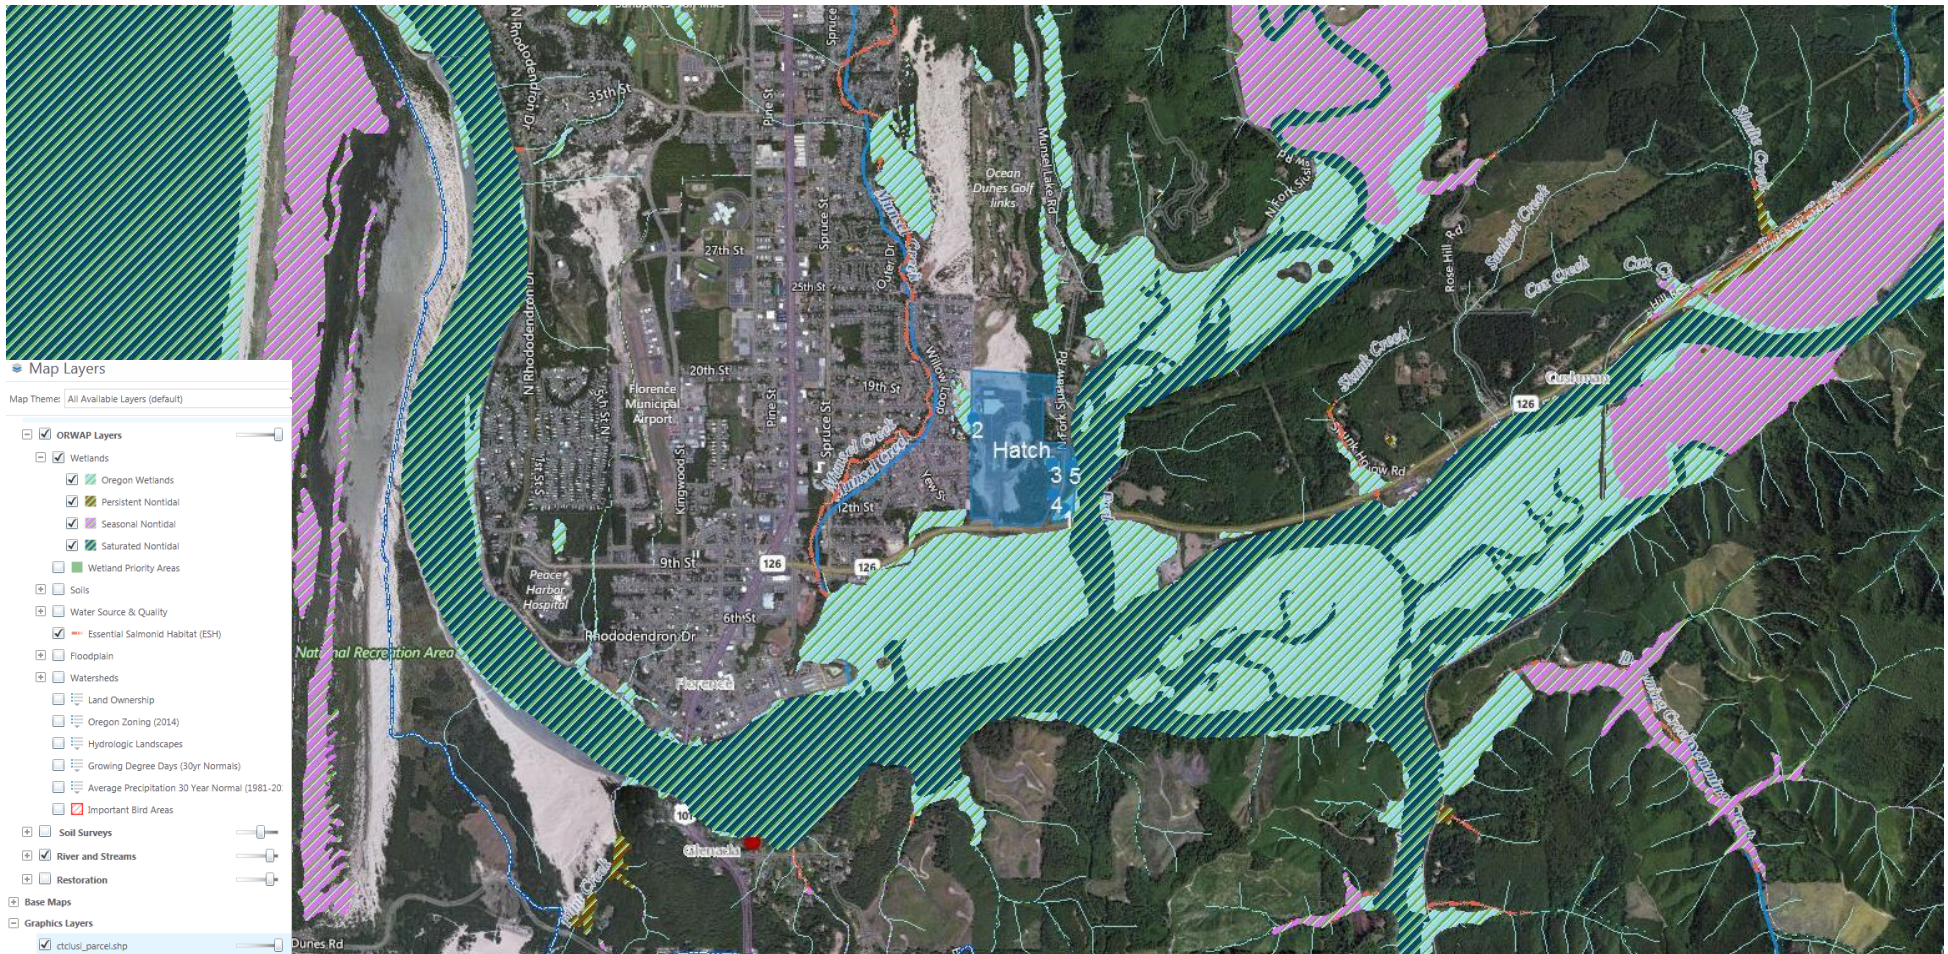
Qa'aich, Siuslaw Watershed; Lower North Fork Siuslaw River Sub-basin

The Qa'aich tract is a 104.62 acre parcel located in the city of Florence, Oregon at the confluence of the Siuslaw North Fork River and the mainstem of the Siuslaw River. According to the Lane County Regional Land information Database, 57% of this tract is dune land and is characterized by “hummocky topography” as a result of sand dune deposition and deflation of the sand. Historically, this property was a traditional village site. During the middle of the 20th century, a small lumber mill was constructed as well as a bridge crossing over the North Fork of the Siuslaw River. Today, this property contains Three Rivers Casino and Hotel, a wastewater treatment plant, drinking water distribution, source water protection; wastewater irrigation; and multi-family residential housing.

According to the National Wetlands Inventory (NWI), this property contains a freshwater pond (PABF) that comprises approximately 2.82 acres, another freshwater pond (PUSC) that is shared with the Retaining Ponds tract owned by the Tribes comprising approximately 0.032 acres, and 7.06 acres of estuarine and marine wetland type E2EM1P.

There are several wetlands that occur on this property. Point 1 and Point 5 mark tidally influenced wetlands that share many of the same environmental issues, including non-native invasive species and sedimentation and pollution accrued from nearby roadways. Illegal dumping has been observed on this portion of the Qa'aich tract. Point 2 marks a freshwater pond that is encumbered by illegal dumping and dunal deposition. Point 3 also marks another freshwater pond that is home to a plethora of culturally significant wetland species. This pond also suffers from sedimentation and pollution via the adjacent road as well as illegal dumping. The last point, point 4 marks a wetland that is inventoried by ORWAP but is not inventoried by the NWI and warrants further investigation as to the extent of the documented wetland. Non-point source pollution mitigation/management will be one of the top priorities to ensuring the health of these various wetlands. Non-native invasive species removal will also be an important management strategy.

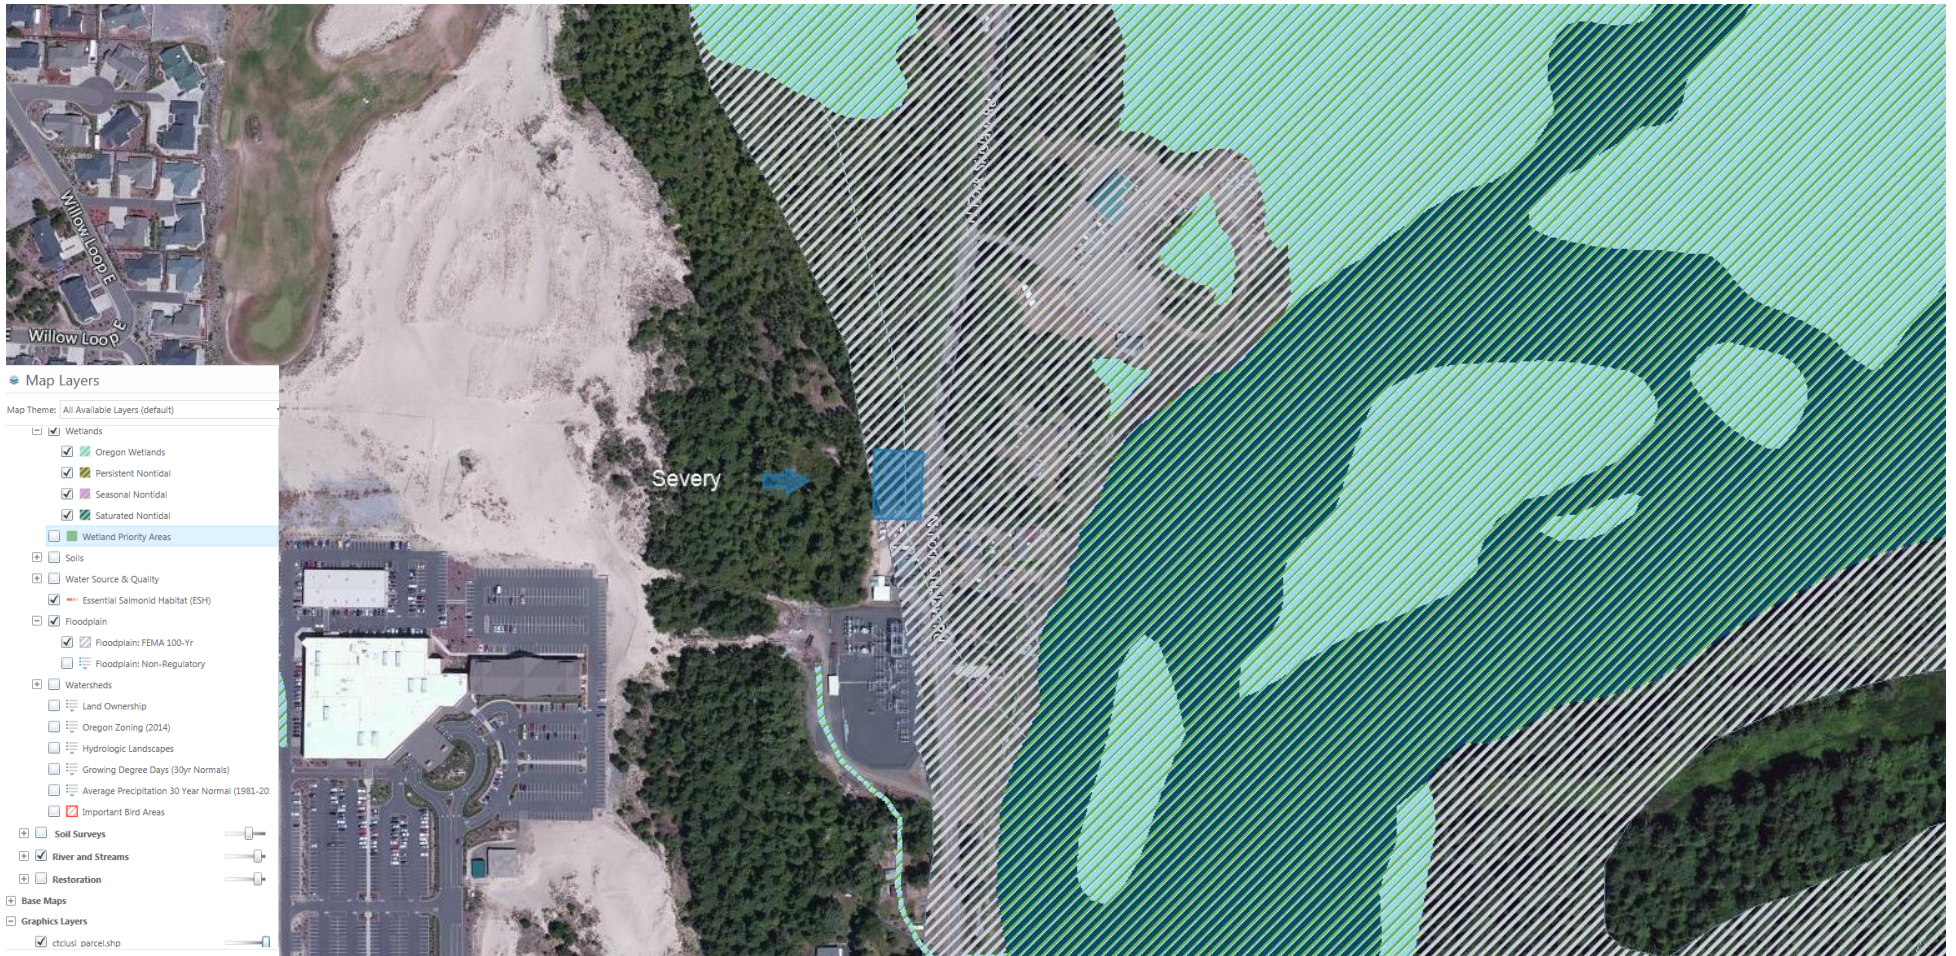
Severy, Siuslaw Watershed; Lower North Fork Siuslaw River Sub-basin

The Severy tract is a 0.56 acre parcel located in the city of Florence, Oregon bordering the Northeast corner of the Tribes' Qa'aich tract. It is composed of a mixed stand of conifers and low-lying shrubs.

Approximately 0.18 acres of riverine wetland type (R5UBH) are inventoried on this property.

The NWI shows that a creek that occurs on this property links the North Fork Siuslaw River and a freshwater forested/shrub wetland (PSSC) that partially occurs on the Tribes' Ocean Dunes Property just north of the tract into. Environmental concerns include excess nutrients from fertilizers and other contaminants used for lawn care that leach/runoff into the freshwater forested/shrub wetland, which could eventually make their way into the creek and ultimately, the North Fork Siuslaw River. Enhancement of native wetland plant species that help to filter contaminants/sediments may prove beneficial in the reduction of toxins that reach the North Fork Siuslaw River. Encouraging the Ocean Dunes Golf Course to utilize eco-friendly weed killers and fertilizers will help to alleviate nutrient loading and contamination concerns in this wetland drainage.

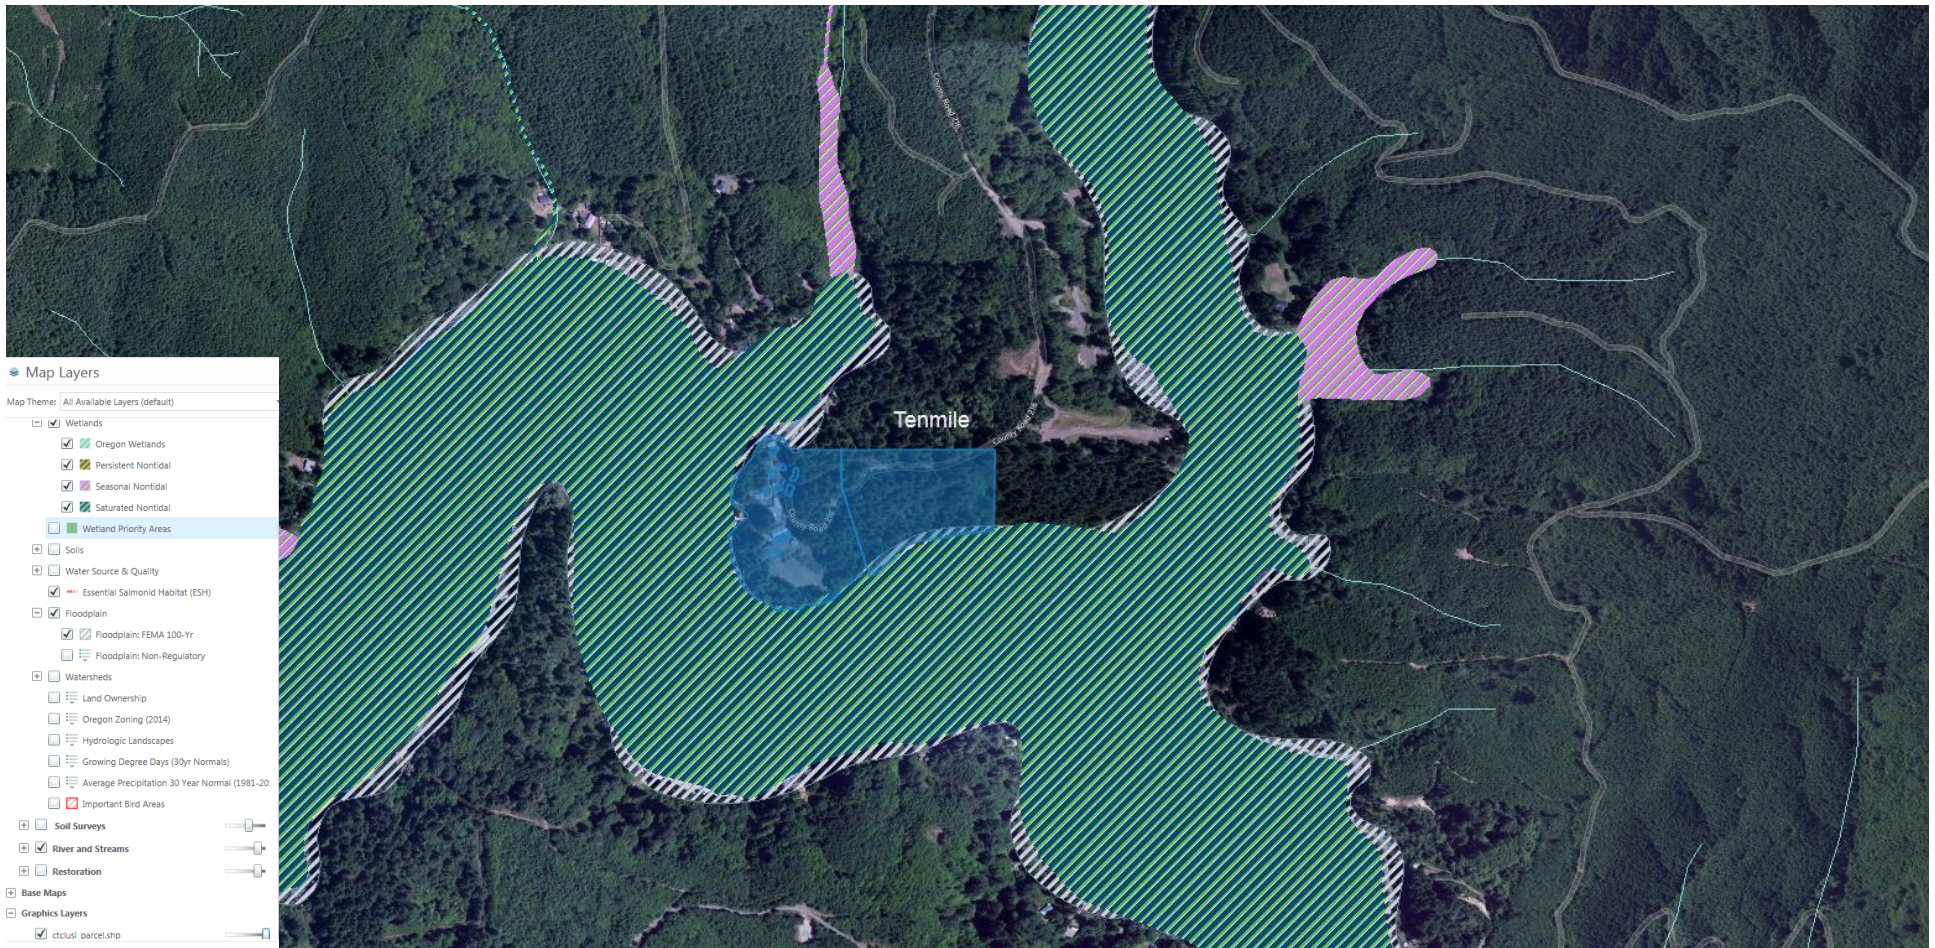
Tenmile, Coos Watershed; North Tenmile Lake Sub-basin

The Tenmile Lake tract is a 14 acre parcel that borders North Ten Mile Lake in Coos County, OR. A mixed stand of western hemlock, Douglas fir, and cedar are found throughout the property. The site includes the original residence, which was built in 1948, along with a lodge, 5 cabins, staff and guest facilities, 2 boat dock buildings, storage and workshop buildings, a pavilion, and a small barn. Most of the buildings were constructed in the 1970's and the boat houses were built in 2006. Some buildings are still in the process of being remodeled or removed.

According to the NWI, this property is comprised of 0.15 acres of freshwater emergent wetland type PEM1C adjacent to the boat dock buildings.

Introduced non-native invasive aquatic species, including plants and fish coupled with decreasing water levels attributed to consumptive use and climate change, warming water temperatures, and altered/degraded habitat due to sedimentation and lakefront property development have exasperated the native populations of salmonids and other anadromous fish species, including lamprey, in Tenmile Lakes. Also, heavy nutrient loading from farms and septic tanks from residential homes is contributing to eutrophication and toxic algal blooms, which could pose a potential health hazard to aquatic life and Tribal members. Oil and fuel that leaks from boats that traverse the lake could also pose a potential health hazard to aquatic and terrestrial life.

Restoration project development for this property should include removing non-native invasive species, especially warm water fish and invertebrate species such as bass, bluegill, and yellow perch, brown bullhead catfish, crappie, mosquito fish, and swamp crayfish. Purple loose strife, reed canary grass, *Egeria densa*, scotch broom, and Armenian blackberry are but a few of the non-native invasive plant species that are found in the Tenmile Lakes sub watershed. Removal/mitigation of these non-native flora and fauna and recruitment/enhancement of native populations of aquatic and terrestrial species will prove crucial to the rehabilitation of this degraded coastal lake. Collaborating with the local watershed and Tenmile Lakes' residents will be essential in future restoration endeavors. HAB monitoring will remain a priority until restoration/mitigation efforts have proven successful in the reduction of blooms.

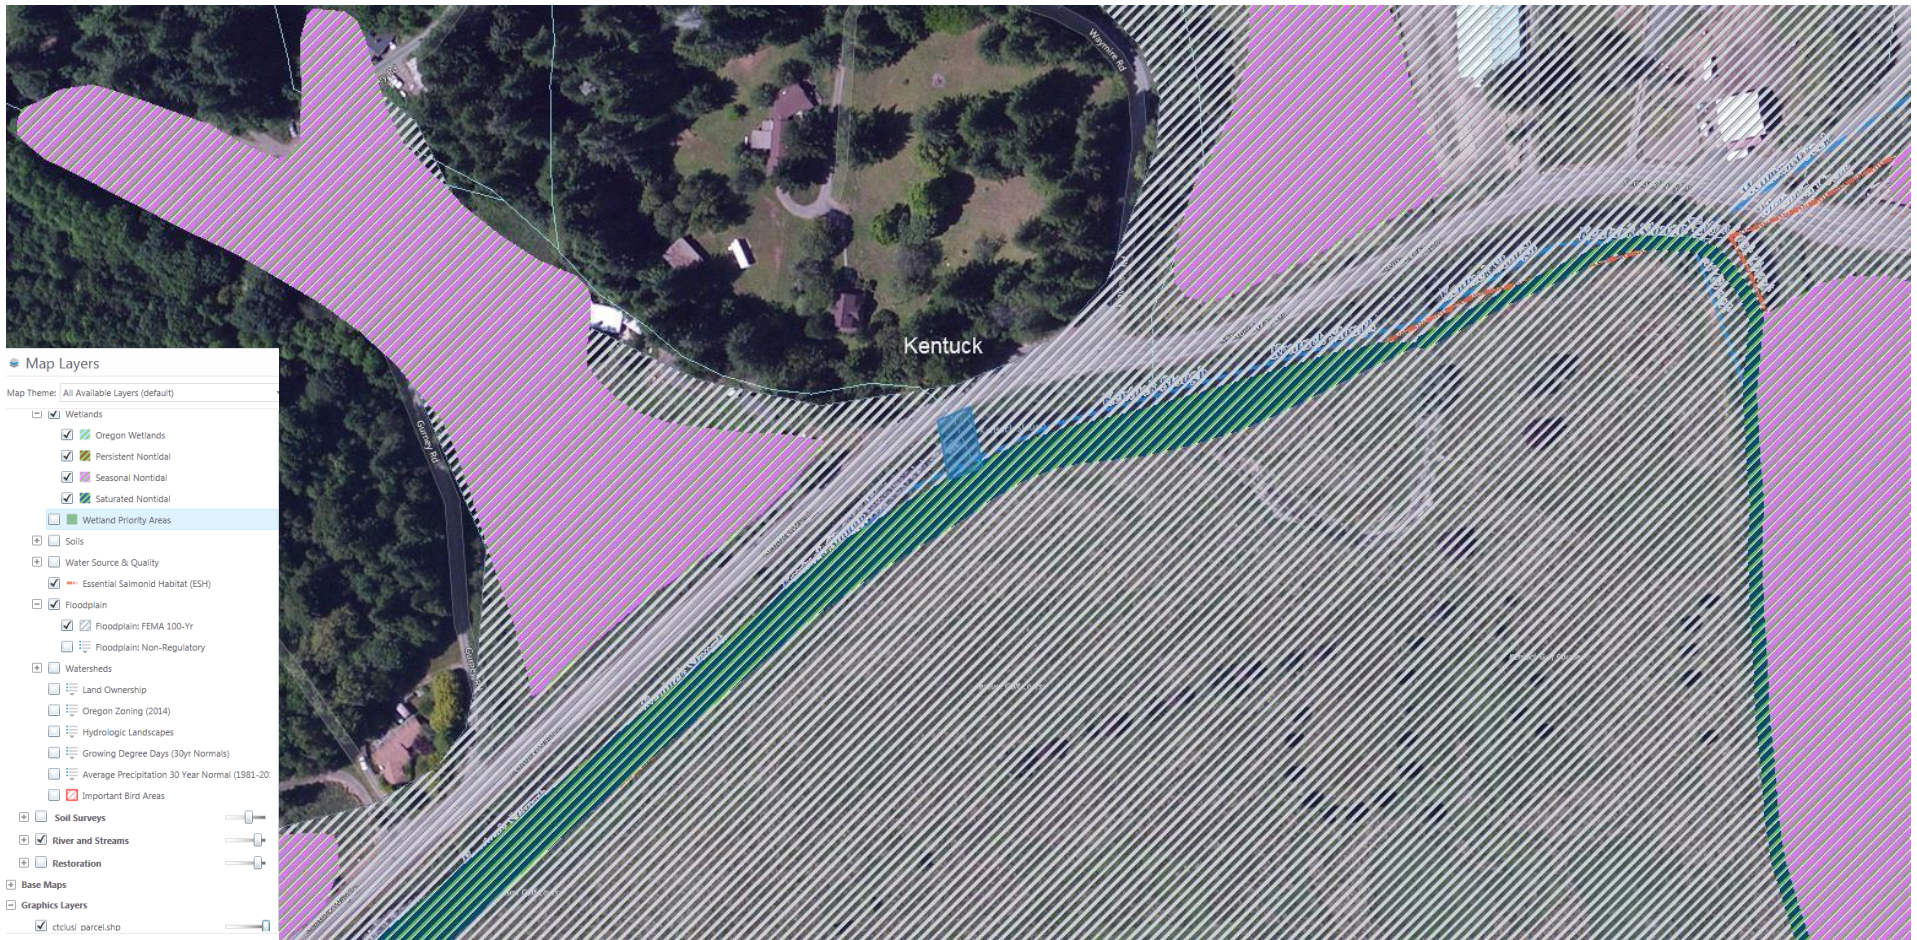
Kentuck Slough, Coos Watershed; Coos Bay Sub-basin

The Kentuck Slough Tract is a 0.12 acre parcel located north and east of North Bend, OR on Kentuck Slough, which is a tributary that flows into the Upper Coos Bay Subsystem, in Coos County.

0.022 acres of freshwater emergent wetland type PEM1R as well as 0.01 acres of riverine wetland type R5UBFx, 0.056 acres of riverine wetland type R1UBV, and 0.0058 acres of R5UBH occur on this tract according to the NWI.

Restoration project development for this property should include removing non-native invasive species, especially Armenian blackberry and reed canary grass, and planting native species that help stabilize the stream bank and capture/filter sediments. Large woody debris placement may also be beneficial for gravel retention and bedload recruitment. Encouraging landowners within the floodplain to allow their lands to be inundated and reconnect floodplain connectivity during off season production where appropriate may prove vital to the reestablishment of overwintering habitat for juvenile salmonids and other anadromous fishes. Collaborating with stakeholders, private landowners, private industry and the BLM and/or Forest Service will be essential to the rehabilitation of the Kentuck sub-basin and the return of salmonids and other anadromous fishes.

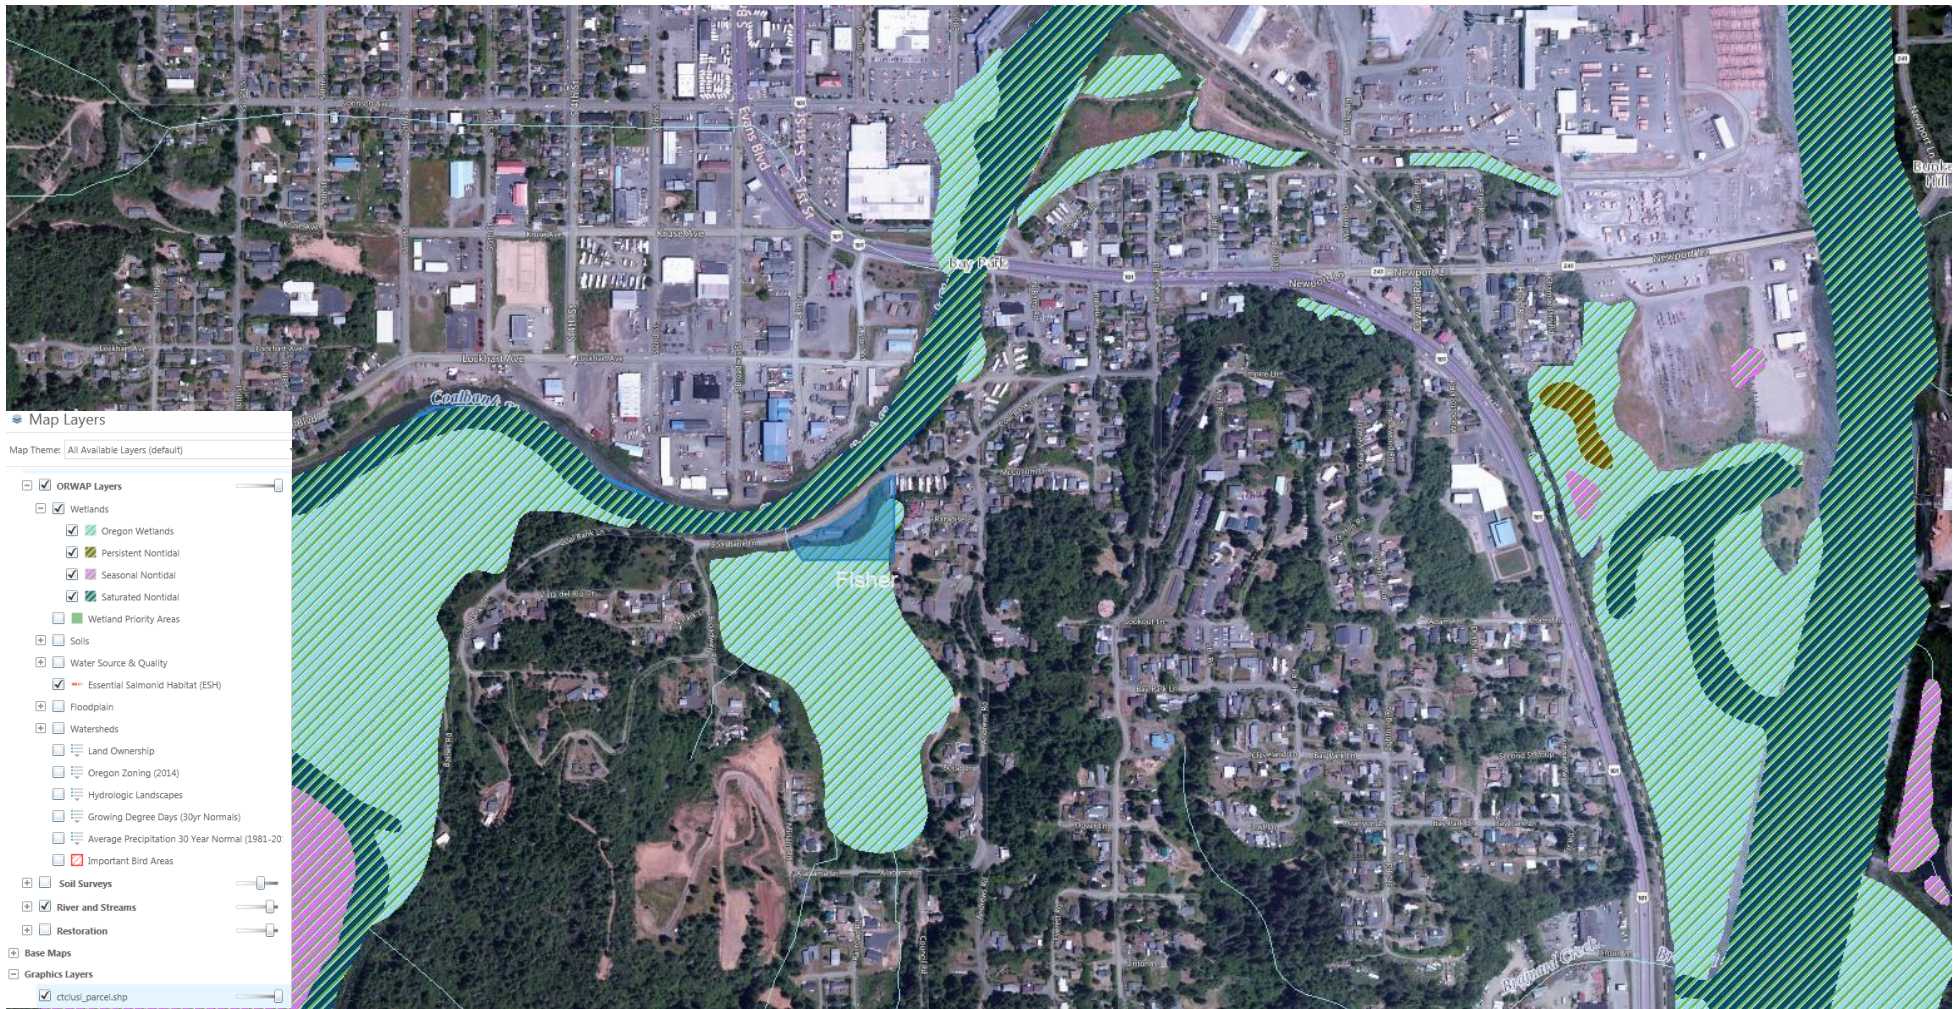
Fisher, Coos Watershed; Isthmus Slough Sub-basin

The Fisher tract is a 2.24 acre parcel in Coos County located southeast of Coalbank Slough and approximately 3000ft south of the southern end of Coos Bay, OR. Historically, this wetland was ditched and dredged as evidenced by the berm that lies adjacent to the building that lies on this tract. Today, a small reach of Coalbank Slough located immediately west of the tract flows into a salt marsh just south of the tract through a culvert that lies under Coal Bank Ln. Freshwater inputs have been observed flowing into the south end of this same salt marsh.

According to the National Wetlands Inventory (NWI), this property is comprised of approximately 2.22 acres of estuarine and marine wetland type E2M1N.

During an on-site investigation of this tract, sediment deposition was observed, as well as a large scour pool, indicating that the exit culvert is undersized and restricts flow. Enlarging the culvert could prove advantageous in improving fish passage as well as enhancing estuarine salt marsh habitat for over wintering juvenile coho and other salmonid species.

wetland species that are present within the slough and salt marsh lands of this tract. Monitoring for contaminants of concern post future restoration activities may need to be performed to ensure that Tribal resources aren't not being adversely affected and available for cultural use.

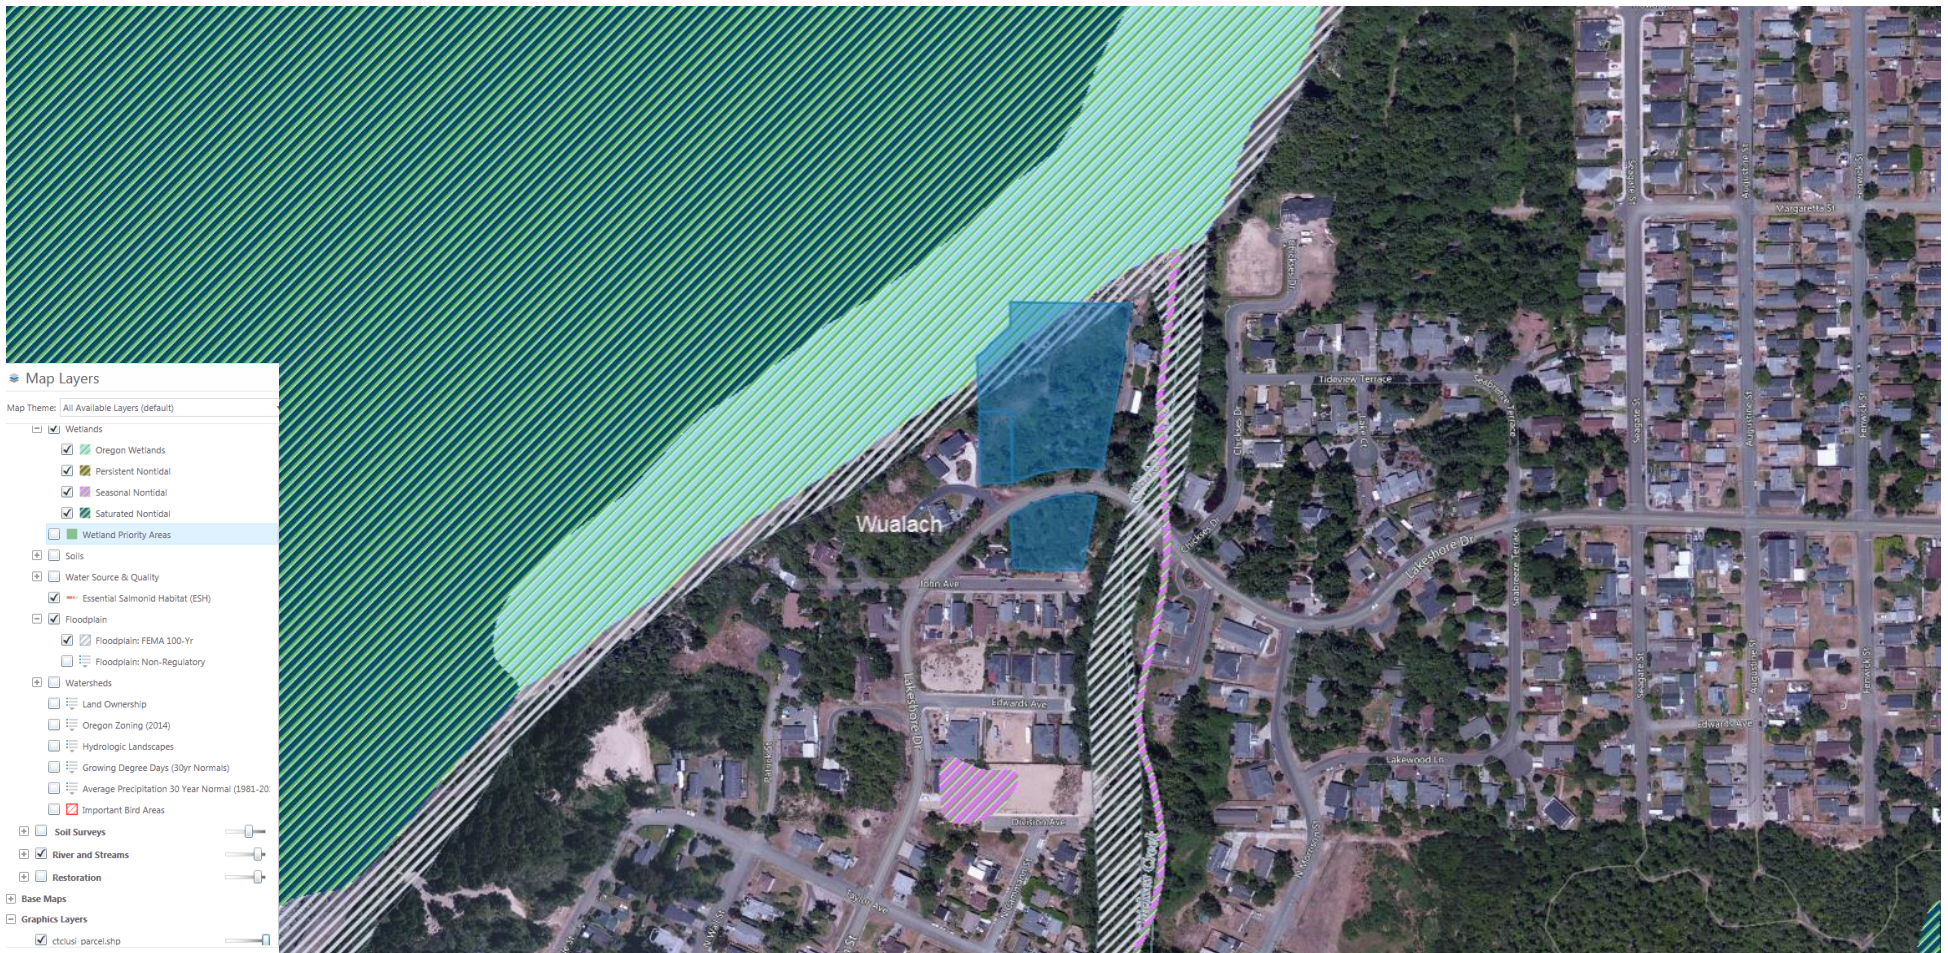
Wualach Complex, Coos Watershed; Coos Bay Sub-basin

The Wualach Complex is composed of 2 parcels that total 3.32 acres and are located immediately adjacent to the lower Coos Bay estuary tidelands on vegetatively stabilized sand dunes overlying an uplifted marine terrace. Historically, this tract was the former site of a Hanis Coos village. Unfortunately, during the 1850's, Tribal members were forcefully removed from their homes at gunpoint and detained by the US Military in fear that

There are no real known environmental issues affecting this wetland at this time. However, due to the changes in the drainage pattern of Coos Bay as a result of colonization and port development (i.e. dredging and dune stabilization caused by non-native invasive European beach grass), sand is no

longer replenishing this dune sheet and is causing the coastline to recede. Potential environmental impacts to tidelands associated with this site are those associated with the overall estuarine habitat of Coos Bay.
