CONFEDERATED TRIBES OF THE COOS, LOWER UMPQUA, AND SIUSLAW INDIANS

Wetlands Inventory and Assessment

November 2016

CONFEDERATED TRIBES OF THE
COOS, LOWER UMPQUA, AND SIUSLAW INDIANS
WETLANDS INVENTORY AND ASSESSMENT REPORT

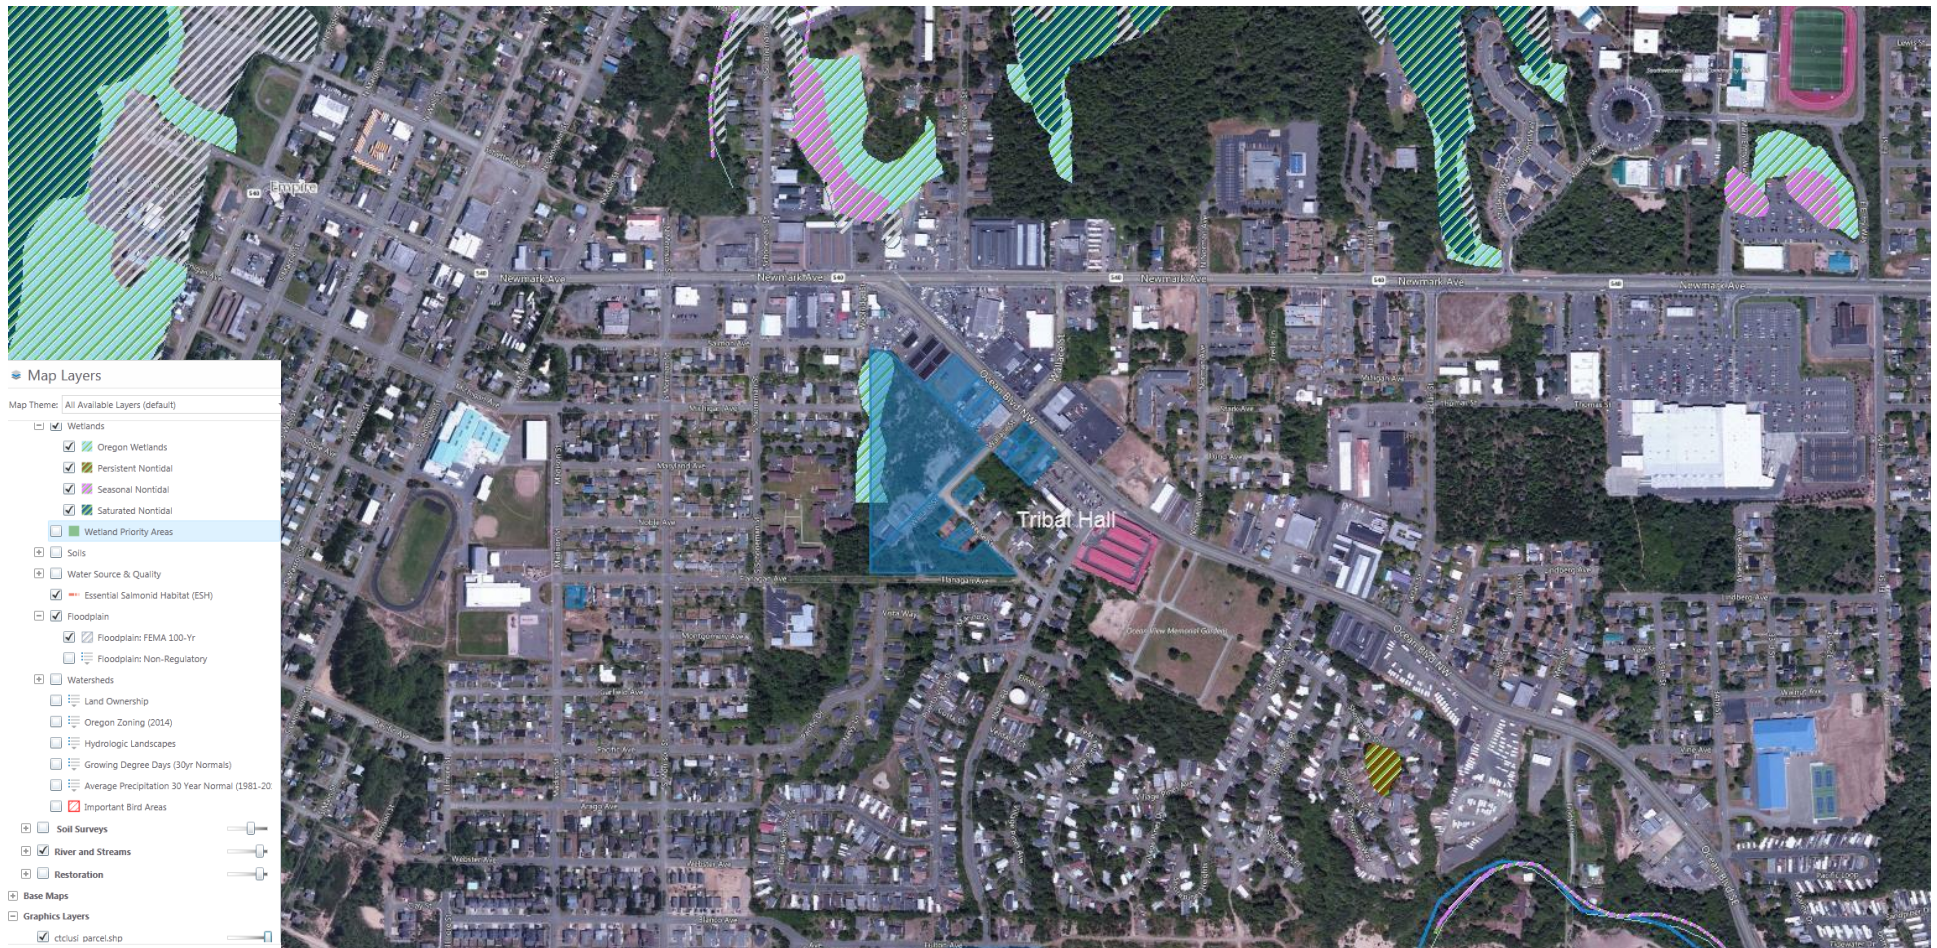
Tribal Hall, Coos Watershed; Coos Bay Sub-basin

The Tribal Hall tract is a 6.12 acre parcel located in the Empire section of Coos Bay, OR. This tract was previously clear-cut by Robertson Timber Co. before it was gifted as reservation land to the Tribes by the Federal Government in 1940. Currently, the Tribal Hall tract houses Tribal Hall, the

Tribes' community center, playground, plank house, sweat lodge, community garden, and the newly built Three River's Casino Coos Bay. At the time of this assessment, a camping area for Tribal members was in the process of being constructed.

During the last onsite investigation for this tract, it was noted that the Three Rivers Casino Coos Bay is near the boundaries of the freshwater forested/shrub wetland inventoried by the NWI. Further investigations will need to be conducted to determine if the quality and boundaries are or will be impacted by the current use of the property. Because this wetland occurs within a residential area, illegal dumping and camping occurs on a frequent basis. Future restoration improvements should include non-native invasive species and trash removal, and enhancement of native wetland species. A more thorough on site investigation will also need to be performed to inventory non-native invasive species as well as culturally significant wetland species, and rare, threatened and endangered species.

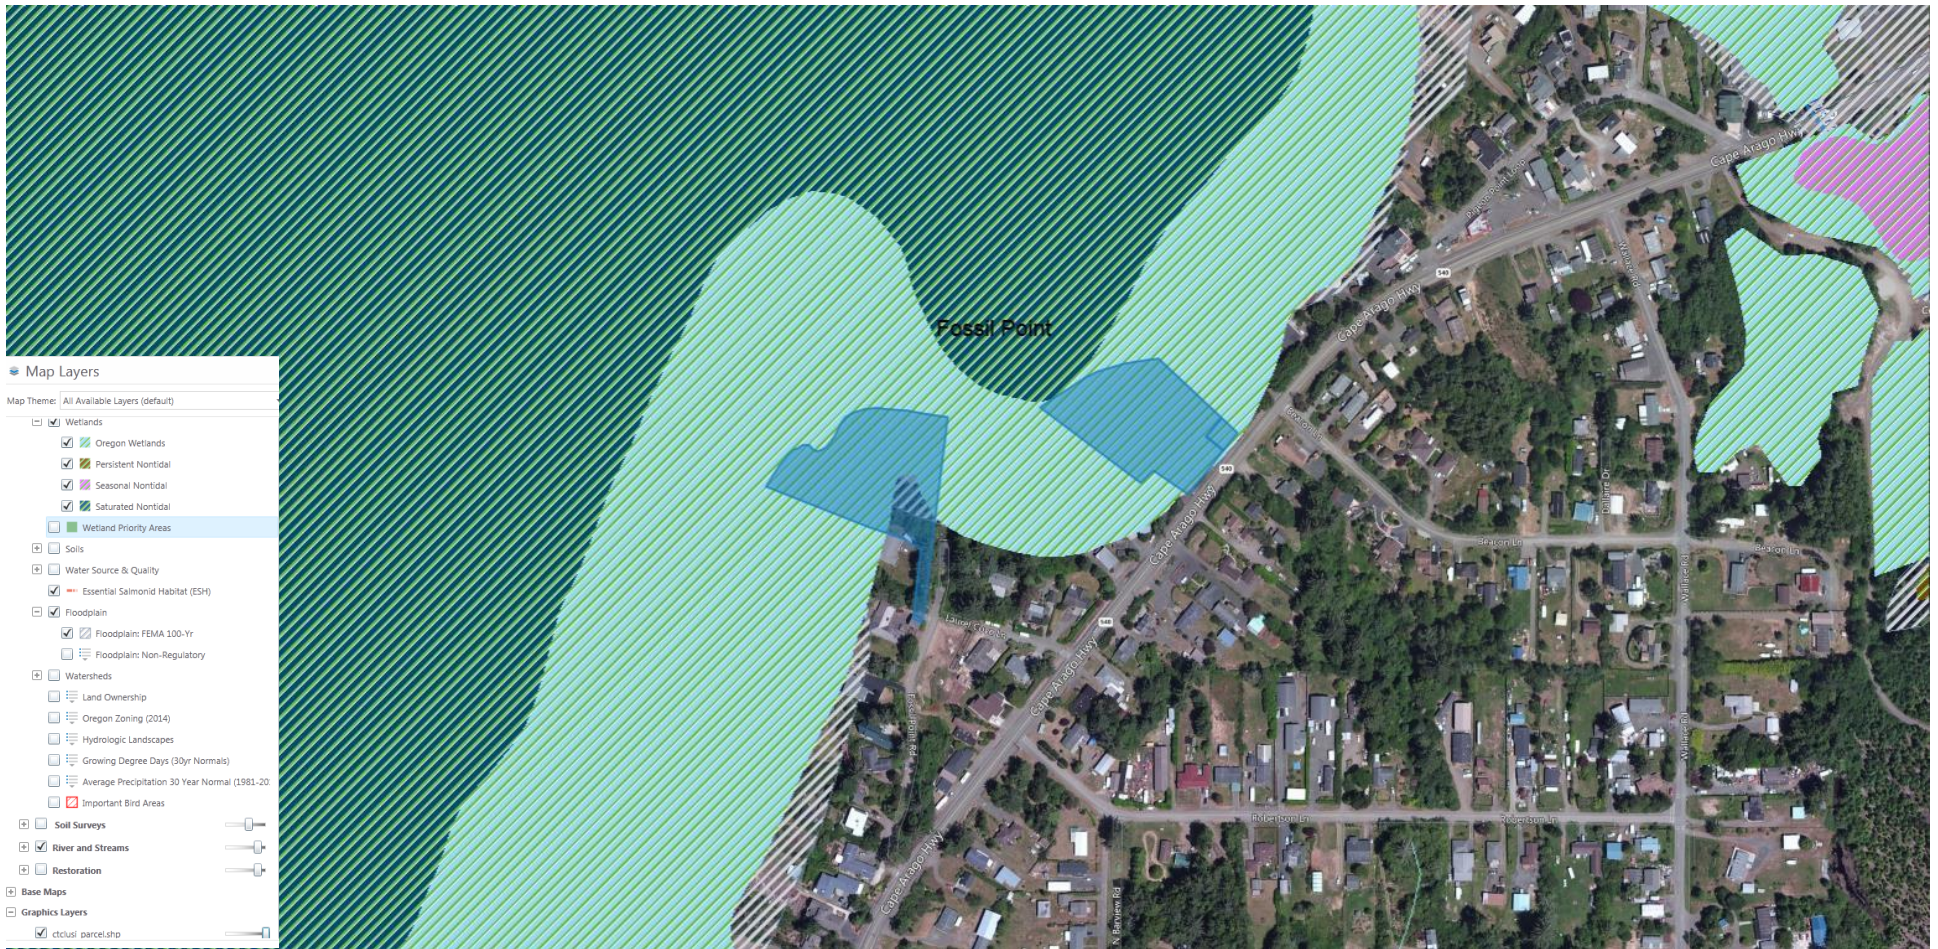
Fossil Point Complex, Coos Watershed; Coos Bay Sub-basin

The Fossil Point Complex is composed of three parcels that total 3.76 acres and are located northeast of Charleston, Oregon along Cape Arago Hwy and the eastern shoreline of the Coos Bay estuary, which is directly east of the Pacific Ocean inlet of Coos Bay. An intertidal fossil-rich marine terrace deposit of the Empire Formation is found in the intertidal areas and contains fossils of marine mollusks and mammals. Fossil Point is located just south of the complex.

According to the National Wetlands Inventory (NWI), this property is comprised of approximately 2.06 acres of estuarine and marine wetland type E2EM1N and 2.76 acres of estuarine and marine wetland type E2Us/ABM.

Shellfish gathered on and near this property (i.e. the bay) can contain elevated levels of saxitoxin, which is primarily associated with paralytic shellfish poisoning, as well as domoic acid, which is associated with amnesic shellfish poisoning. Consumption of high levels of either toxin can cause severe illnesses and even death. Sampling and testing for shellfish toxins may need to be instituted in the future to ensure that these traditional foods remain safe for tribal member consumption.

A more thorough on site investigation will need to be performed to inventory non-native invasive species as well as culturally significant wetland species, and rare, threatened and endangered species.

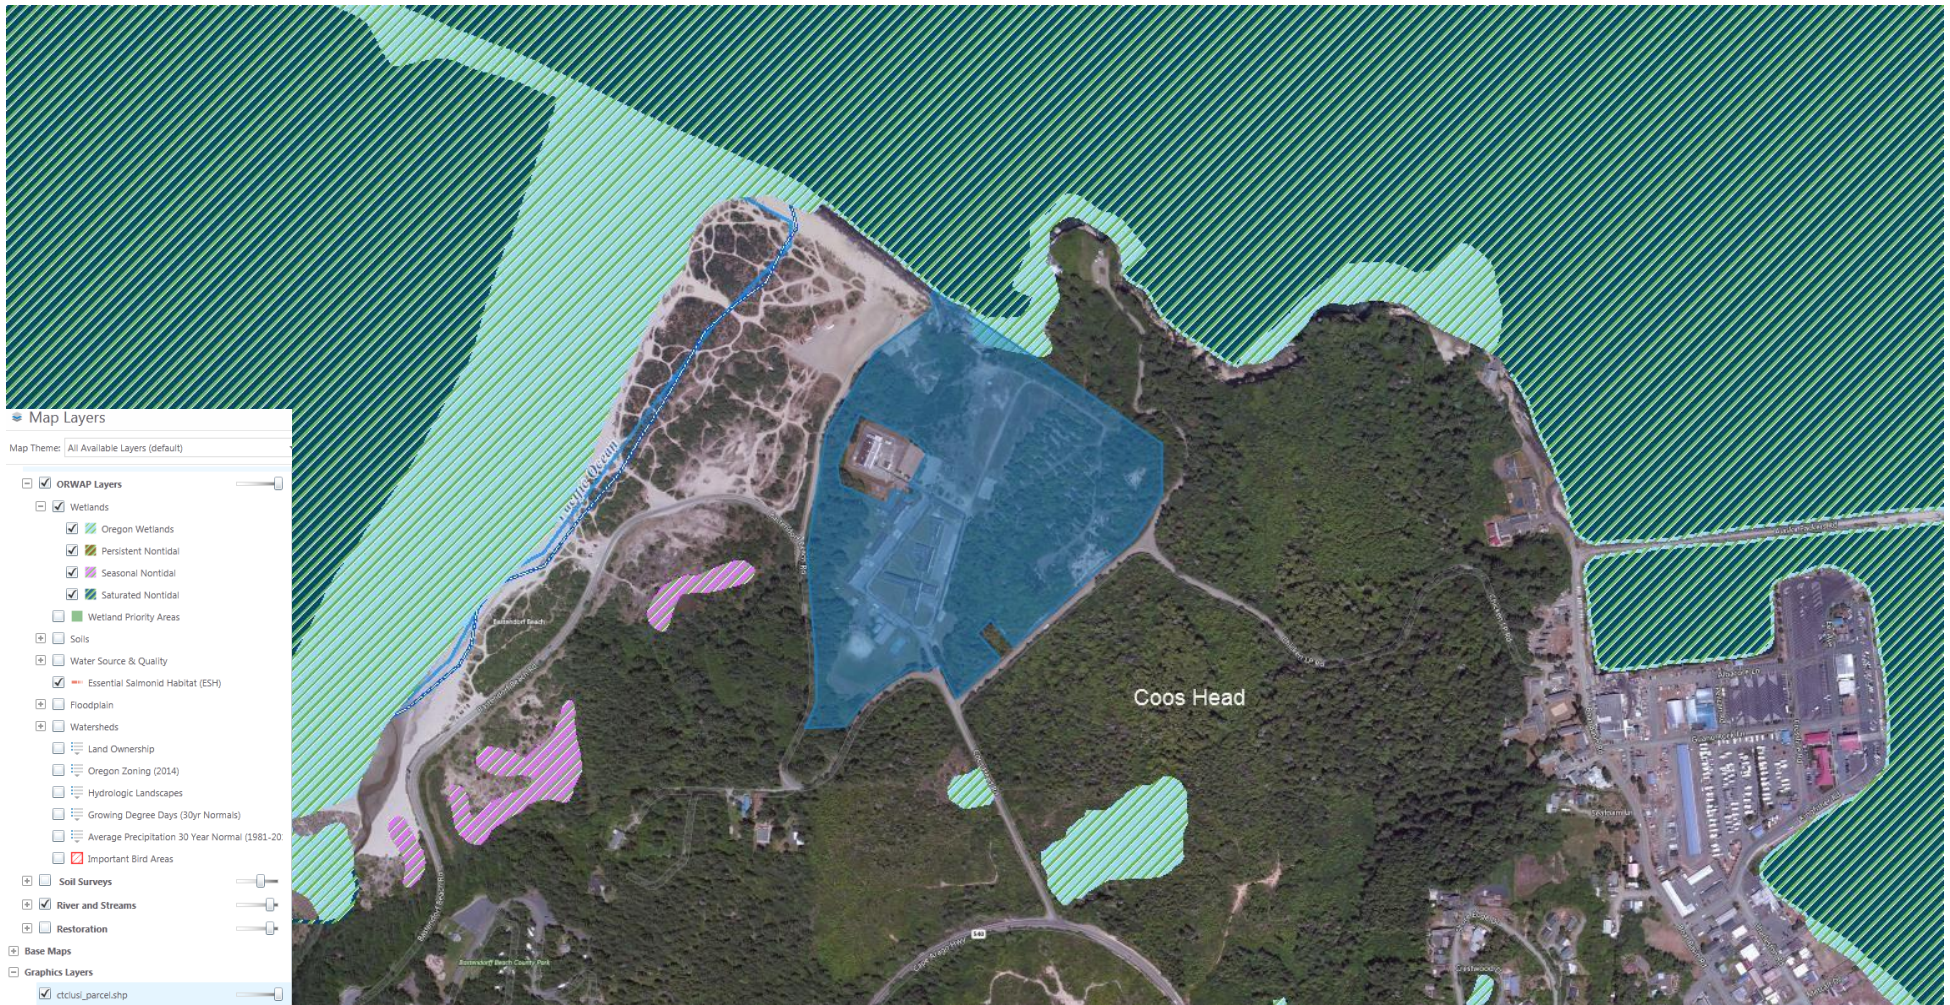
Coos Head, Coos Watershed; Coos Bay Sub-basin

The Coos Head Tract is 43.38 acre parcel located in Coos County, south of Charleston, OR adjacent to Bastendorf Beach. The western half of this tract consists of a few buildings that were previously used for storage and military operations as well as recreational and parking areas. The eastern half of the property is mainly dominated by coniferous trees, especially shore pine.

According to the NWI, this tract is composed of 0.093 acres of estuarine and marine wetland type E2RSN_r, 0.36 acres of estuarine and marine wetland type E2RSN, 0.066 acres of estuarine and marine wetland type E2USN, and 0.067 acres of estuarine and marine wetland type E2USP.

There are no real known environmental issues affecting wetland areas on this tract at this time. A more thorough on site investigation will need to be performed to inventory non-native invasive species as well as culturally significant wetland species, and rare, threatened and endangered species.

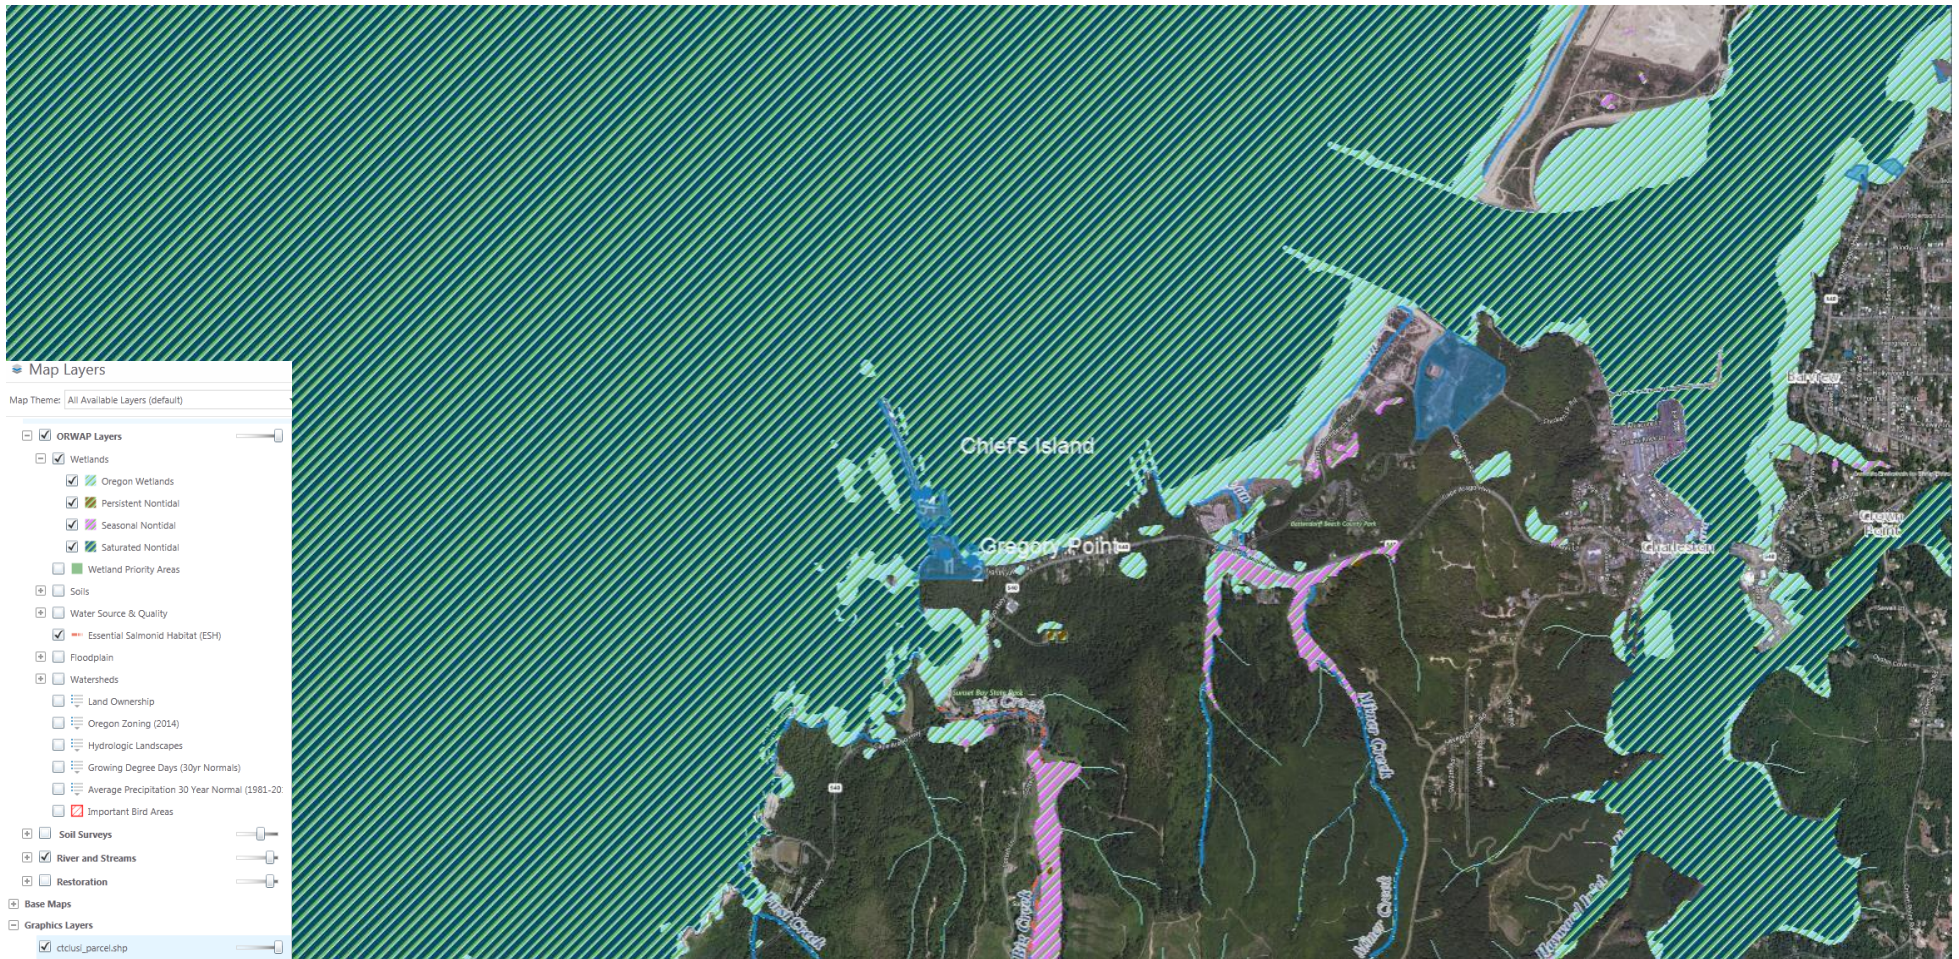
Baldich, Coos Watershed: Big Creek-Frontal Pacific Ocean

The Baldich tract is a 31 acre parcel located in Coos County on an uplifted marine terrace along the Southern Oregon Coast approximately two miles south of the mouth of Coos Bay and consists of Gregory Point and Chief's Island. The uplifted marine terrace consists of a stratum of Pleistocene beach deposits overlying less-permeable Coaledo Formation sandstone. Wave energy excludes abundant/diverse hard substrate communities in the high energy rocky intertidal and subtidal areas on this tract.

Approximately 1.09 acres of estuarine and marine wetland type M2USN, 1.77 acres of estuarine and marine wetland type M2RSN, 0.55 acres of estuarine and marine wetland type M2USP, and 3.85 acres of freshwater forested/shrub wetland type PFOC are inventoried on this property according to the NWI.

There are no real known environmental issues affecting wetland areas on this tract at this time. However, the adjacent properties, particularly Sunset Bay and Bastendorf Beach, are tmdl listed for enterococcus and are closed for water contact recreation periodically due to exceedances in the beach action value for enterococcus (70 MPN). These exceedances have mostly been attributed to agriculture, failing septic systems, storm water runoff, and boating waste. Harmful algal blooms also continue to be an ongoing concern and affect traditional harvesting of razor clams, mussels, crabs, and other culturally significant shellfish species.

Currently, efforts are being made to build capacity that will provide services to Tribal members as well as the community to test for contaminants of concern that are found in shellfish that could affect human health prior to consumption/sale. Future mitigation efforts will include education and outreach programs that create awareness about the dangers of harmful algal blooms, bacteria, and contaminants of concern and what they can do as individuals to help reduce ocean pollution.

A more thorough on site investigation will need to be performed to inventory non-native invasive species as well as culturally significant wetland species, and rare, threatened and endangered species.

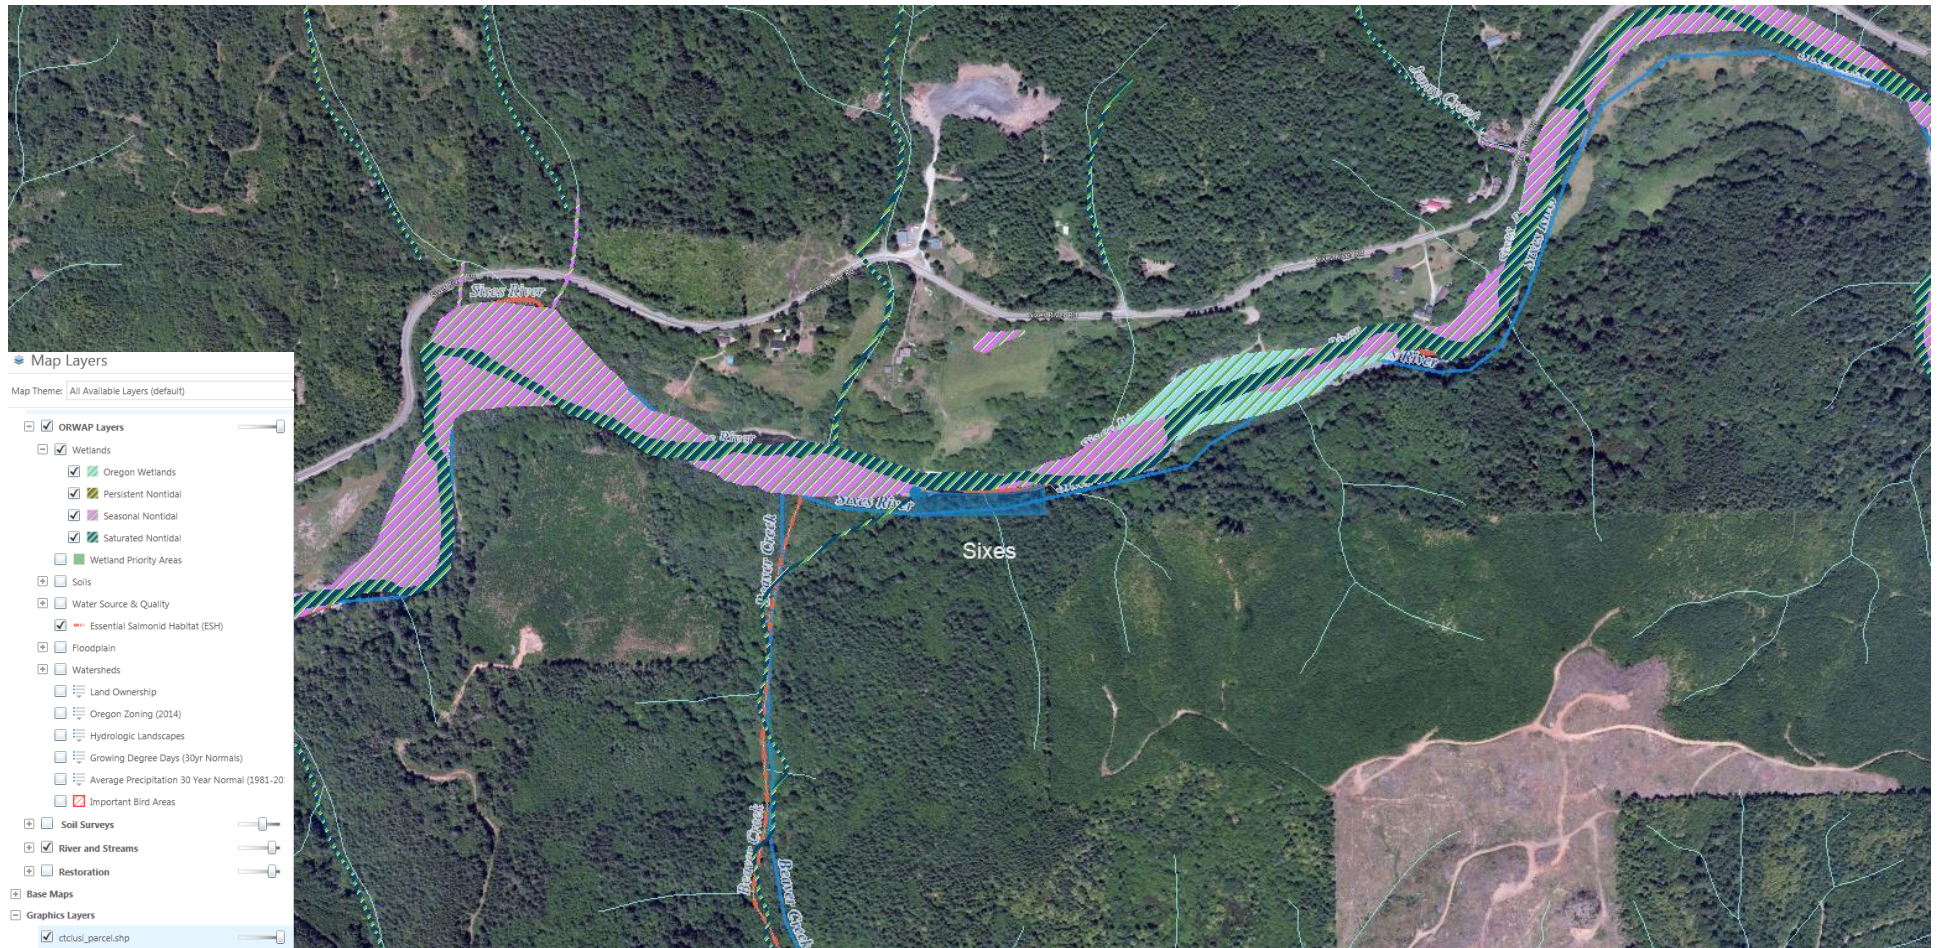
Sixes River, Sixes Watershed; Lower Sixes River

The Sixes River tract is a 1.25 acre parcel located on the south side of the lower mainstem of the Sixes River adjacent to milepost 2 on Sixes River Road in Curry County, Oregon. Sixes River is almost entirely situated within Curry County except for a small arm of the Upper Sixes Main-Stem sub-watershed that extends into Coos County, flowing in a westerly direction and terminating in the Pacific Ocean just north of Cape Blanco. Beaver creek enters the Sixes River just downstream of the tract. Forestry is the most dominant land use in the Sixes watershed, followed by grazing and agriculture in the lower portion of the basin.

According to the NWI, this property is comprised of approximately 0.07 acres of riverine wetland type R4SBC, 0.006 acres of riverine wetland type R3UBH, and 0.09 acres of riverine wetland type R5UBH.

During the last on-site investigation of this tract, beaver dams were observed just upstream of the property, which seemed to be helping to dissipate stream energy and create deep pools and other complex habitats, including cold water refugia, which are beneficial to all salmonids and other fish species' life histories.
